Manhole Inspection Summary

Manhole # S27K__021MH

Insp Date: **6/3/08 10:32 AM**

Location Address: **side of 857 Ramsay St** Cross Street: **S Poppleton St**

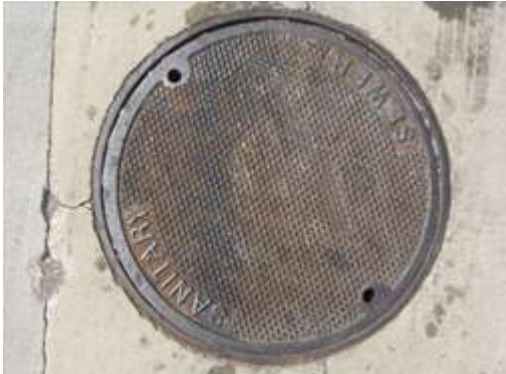
Cover View

Cover Shape: **Circular** Diameter: **31.** (in.) Length: **0** (in.) Dist A/B Grade: **0** (in.)
5

Type: **Sanitary** Condition: **Sound** Cover Material: **Cast Iron**
